## Documentation and Conservation of Bandar Shahi Mosque, Narayanganj, Dhaka, Bangladesh

### Abstract

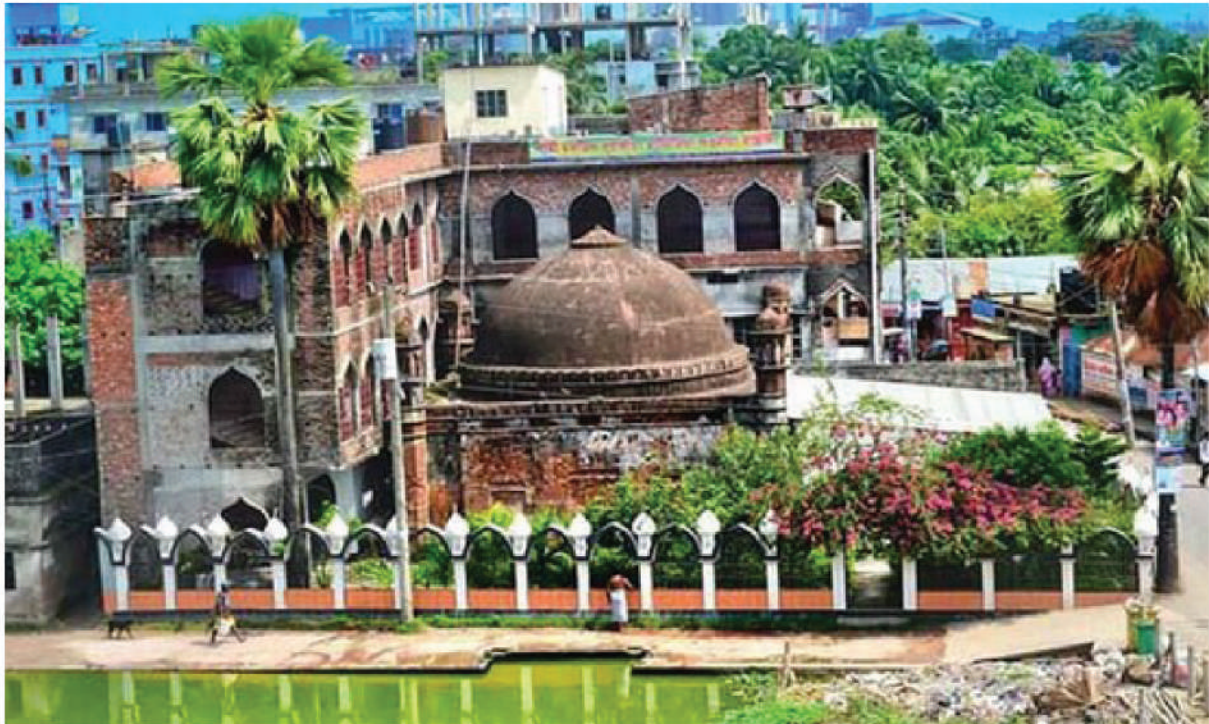
Figure 1: Existing View of Bandar mosque

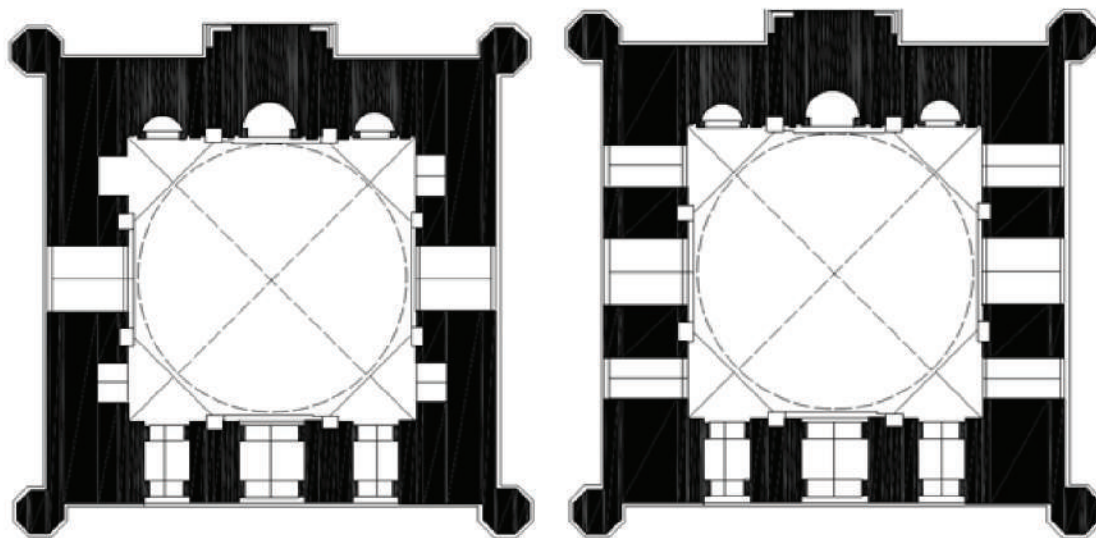
Bandar Shahi Mosque is a single domed mosque, the dome being the most sophisticated and popular form of the sultanate period. The interior diameter is 6.2 meters and the exterior diameter is 9.70 meters. There are three entrances, main entrance is located in the center, another towards the east and two others are located on the north and the south. The main entrance is wider than two others and it is 2.2 meters high and 1 meter wide. The four octagonal towers at the four corners are the main structural support for the roof overlaid on it. The towers are not too high on the cornice which reflects the sultanate architecture.

Figure 2: Plans of Bandar mosque

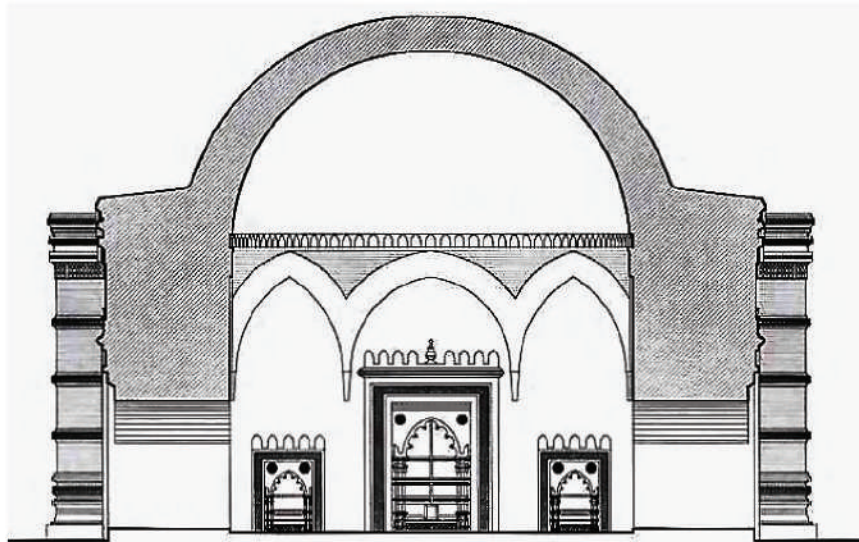
Figure 3: Section of Bandar mosque

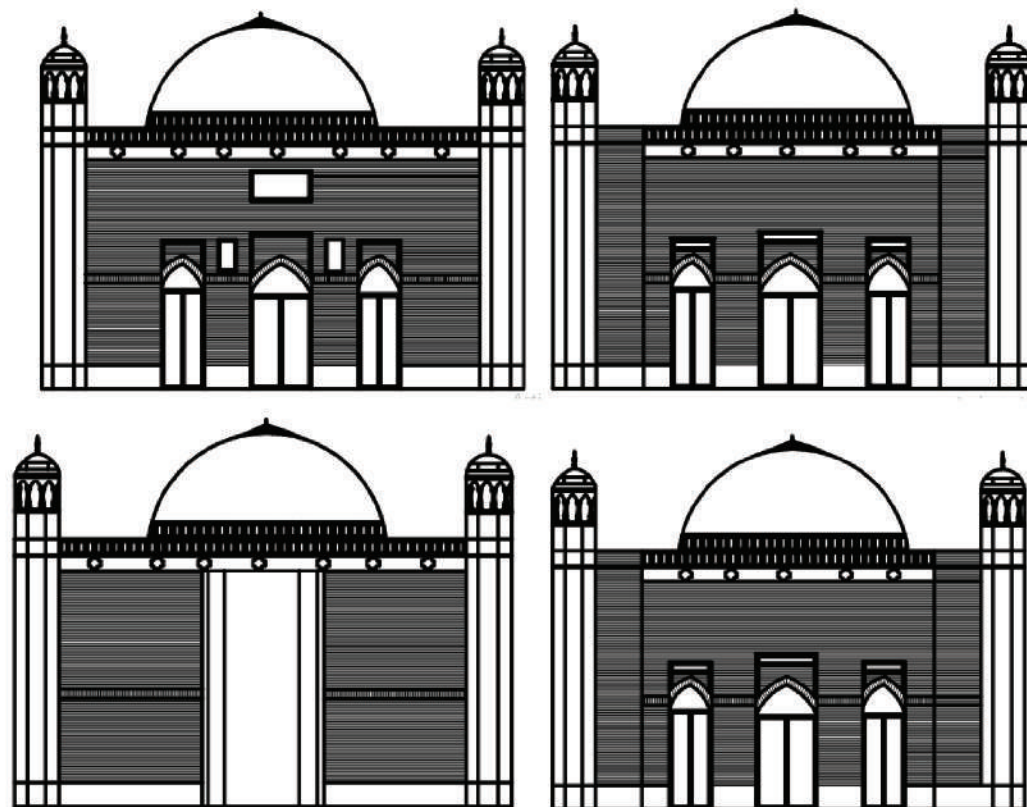
Figure 3: Four Side Elevations of Bandar Shahi mosque

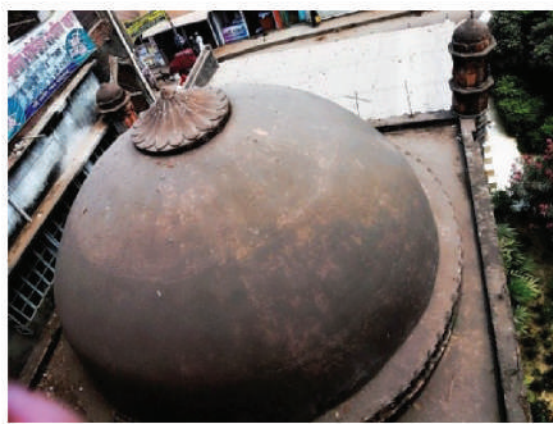
The development starts from there. The traditional pendentive squinch system was the main feature on sultanate of Bengal period. Inside of the dome is normal white wash and on the outside there is no color which indicates the antiquity of the mosque.

Figure 4: Outer surface of the dome without any color

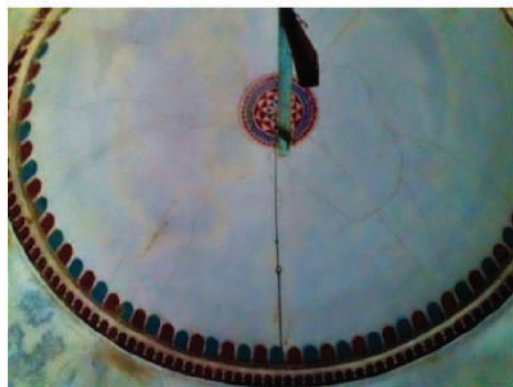
Figure 5: Inner surface of dome with white paint and crack

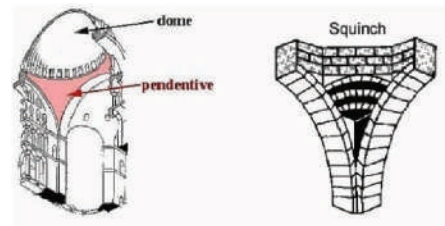
Figure 6: Details of Dome

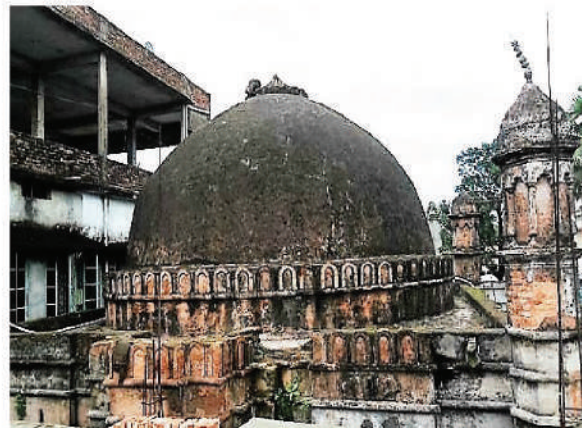
Figure 7: Present condition of the mosque

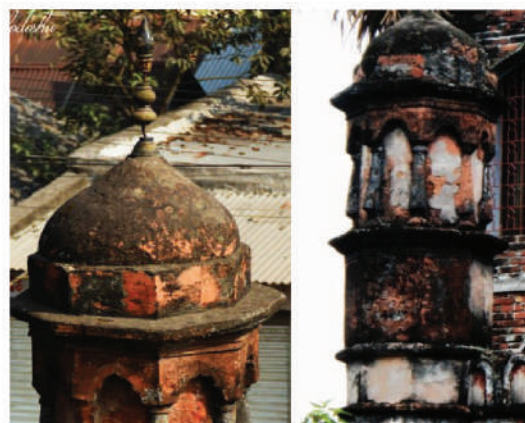
Figure 8: Present condition of the mosque

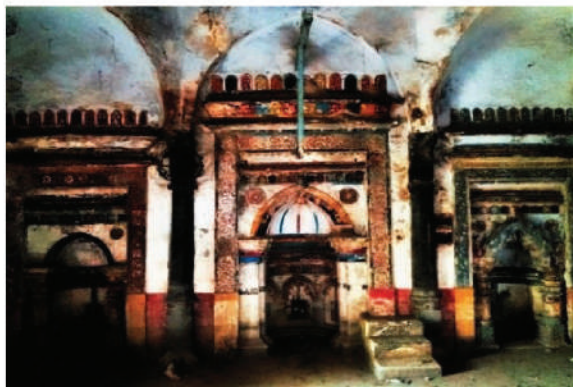
Mihrab is one of the important features of mosque. There are three mihrabs on the western wall of the mosque. The central mihrab is larger than the other two adjacent mihrabs, and it's highly ornamented.

**Figure 9:** Three mihrabs and the port of sahar

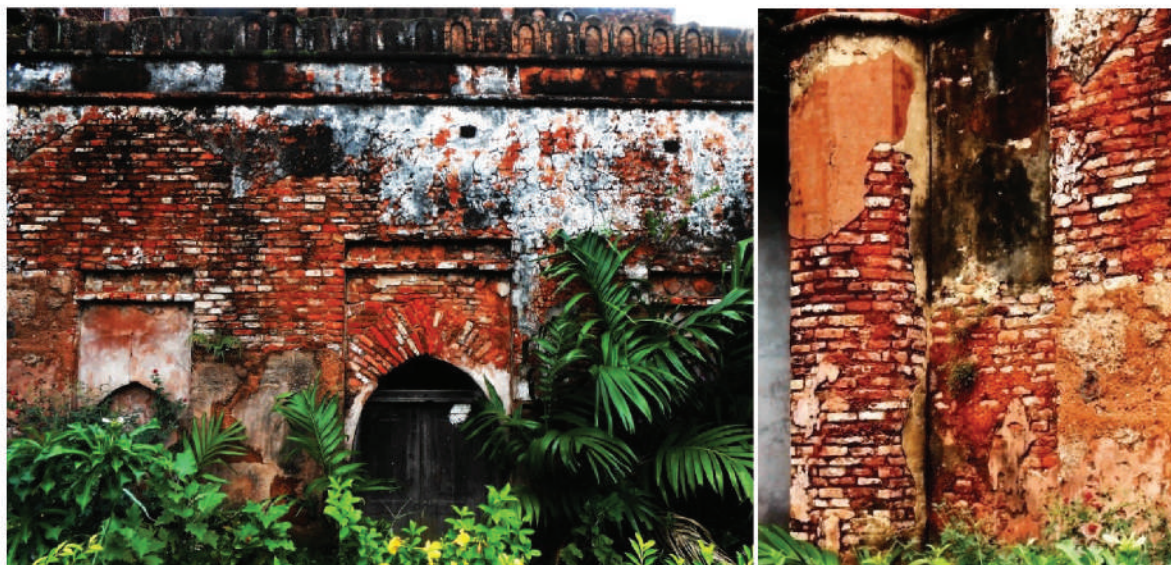
The walls are extremely vulnerable. Because of dampness the plasters are almost falling down. The best solution could be to check out the dampness, cleaned the walls and re plaster them. We must be careful that, the original material and structure will not be lost.

The outer wall between the old mosque and the newly built mosque is damaged due to moisture. The eastern wall is completely closed and there is no way of facilitating natural ventilation and sunlight. It is suggested to remove the dirt, dampness, harmful material from the damaged walls and demolish the new extended mosque. It will then help to circulate adequate light and ventilation. If the extension is important for more accommodation, it is suggested to plan in proper way.

**Figure 10:** The damage found in the mosque

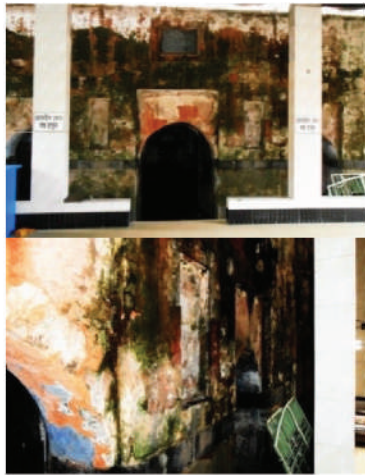
**Figure 11:** The fungal and mouse grew on wall and the new structure built without respecting the monument

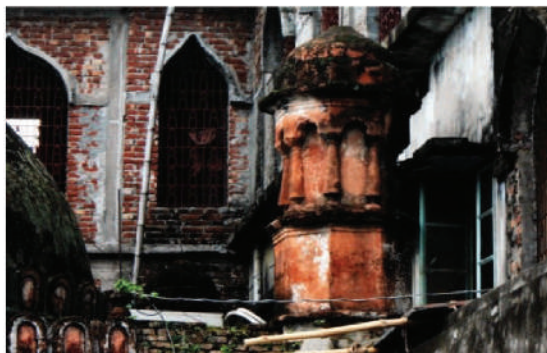
Some parts of the mosque almost broken specially the pillars which was decorated with fruits and floral patterns. The missing ornamentations and missing part can be recreated but it has to be distinguishable from the original by color or material. the main objective is to save the maximum heritage value not only to make a new one. It must be also to be by the restoration work. It is the main aim to save the maximum heritage value not only to make a new one.

**Figure 12:** Missing parts of the mosque.

Care must be taken techniques and color will use for painting and follow like the same as it is possible.

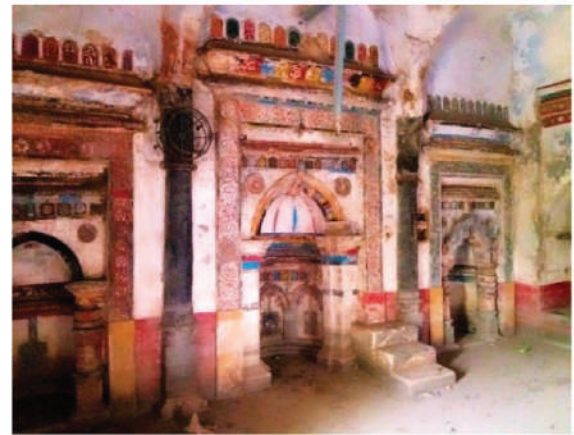
**Figure 13:** Interior view of the mosque

For interior restoration it is necessary to keep and respect the original material and the aesthetic values. It cannot be justified to remove all the historic evidence and made it totally new. The concept of restoration and conservation is to save the old and heritage values.

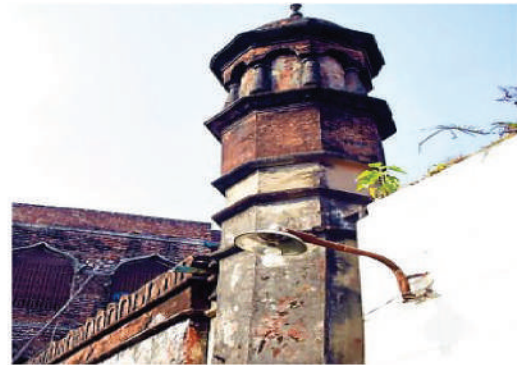
Figure 14: Stone conservation

On the other hand of restoration, we can use the new technology if the traditional techniques fail to save the heritage but at certain extent. And the process of restoration is very difficult to preserve and reveal the aesthetic and historic value. Some examples of proper restoration in many countries those are following the international rules.

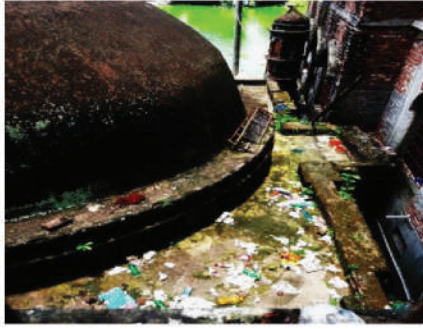
**Figure 16:** Stone conservation

In order for the restoration of the mosque, several steps will be needed. First structural and architectural investigations are needed. It is necessary to train the crafts men. Regular Monitoring and investigation is also necessary thereafter.
